312 9th Avenue North

ARC #3

Date: February 11, 2022

GRAPHITE

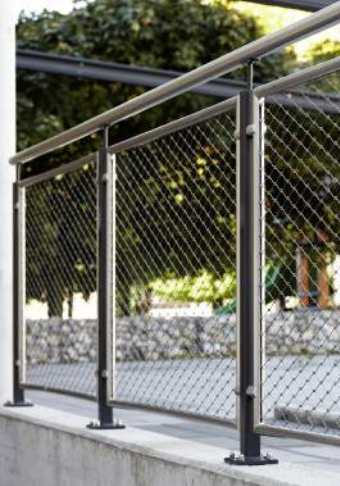
Example of proposed open mesh railing 5

In this option, no infill windows are proposed (1). The existing openings will be left as open apertures to promote visual and auditory connection to the street from seating at the terrace (2). A guardrail with infill panels is required for fall protection (3). Woven metal mesh with a high degree of transparency is proposed as the guardrail infill material (see previous page for representative example).

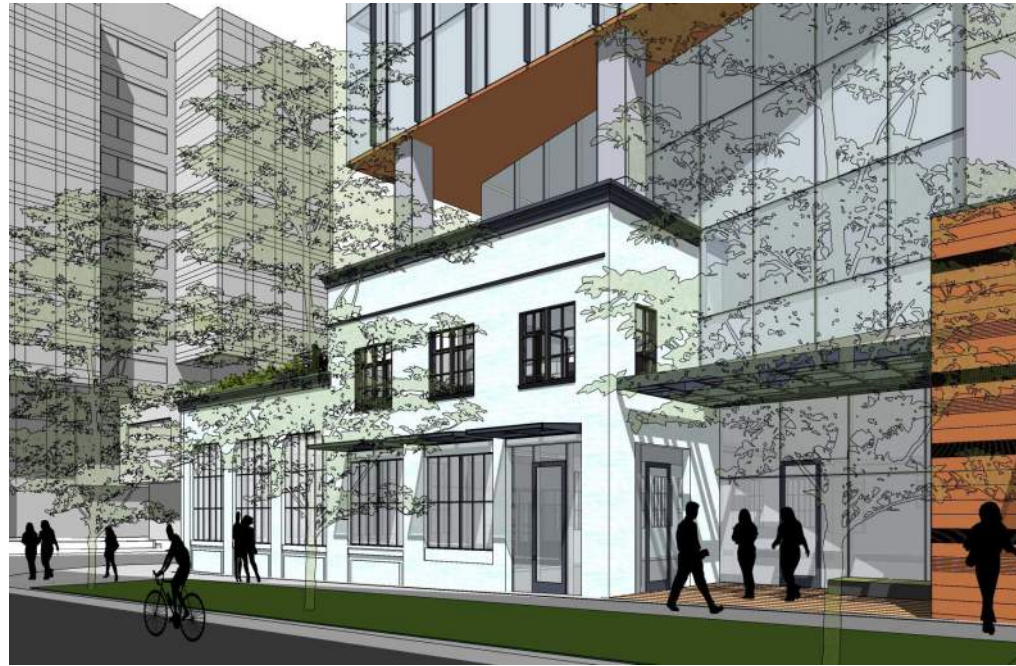
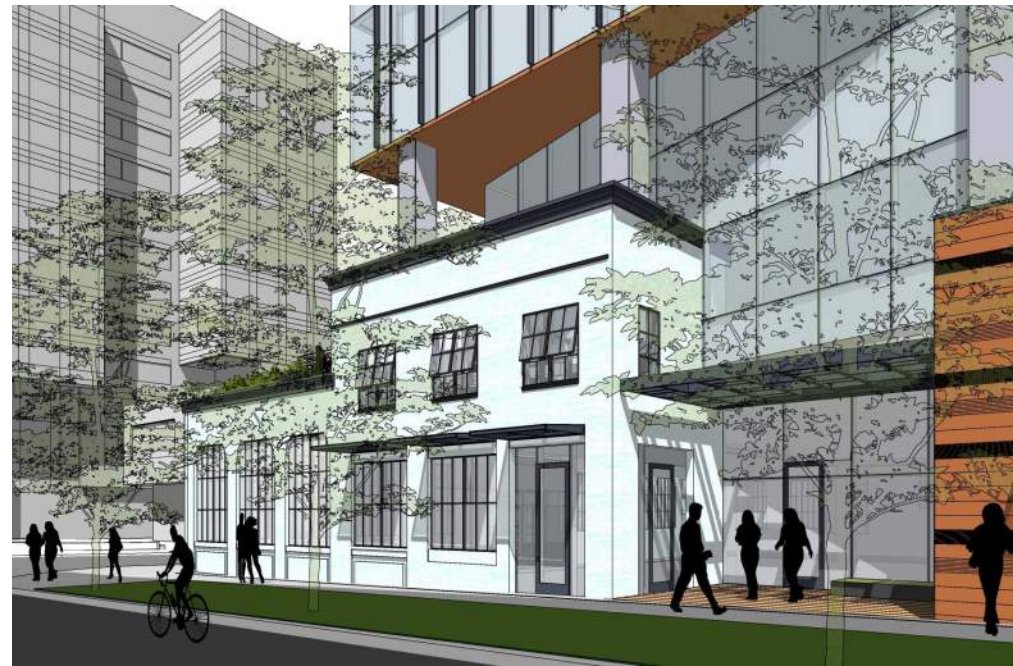
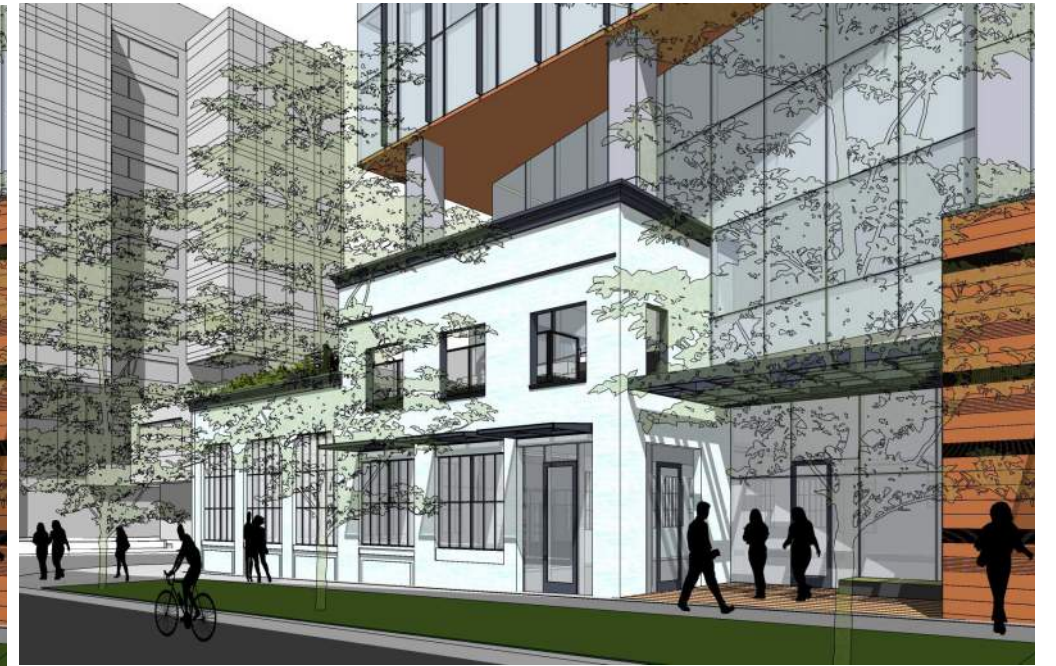
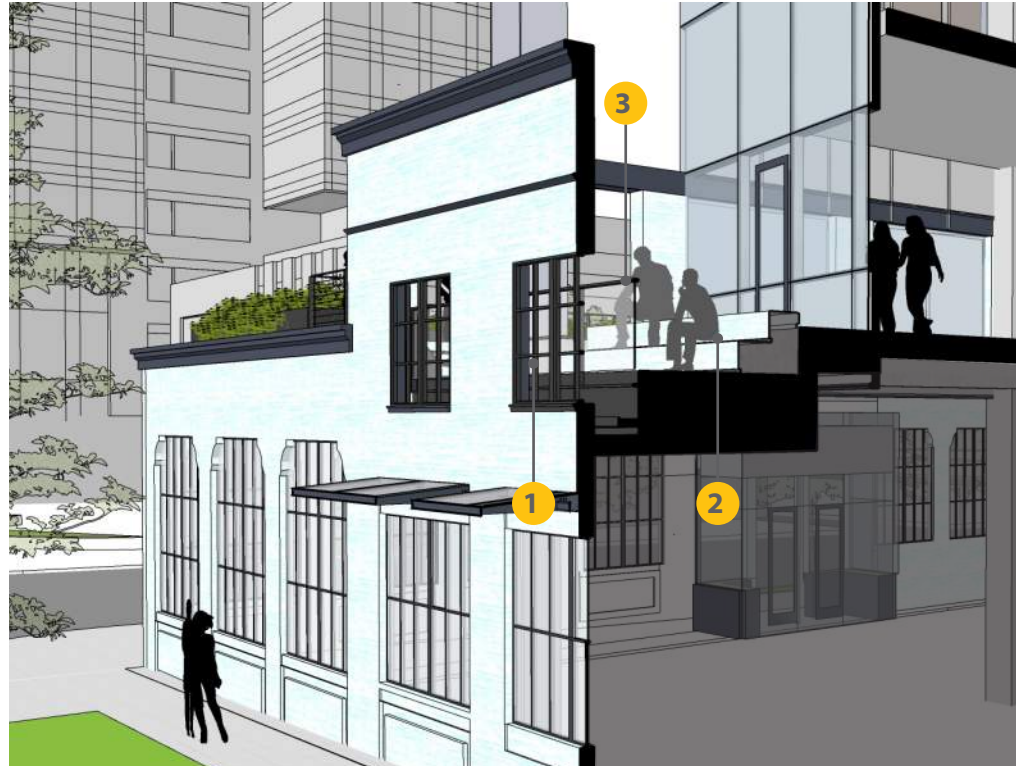
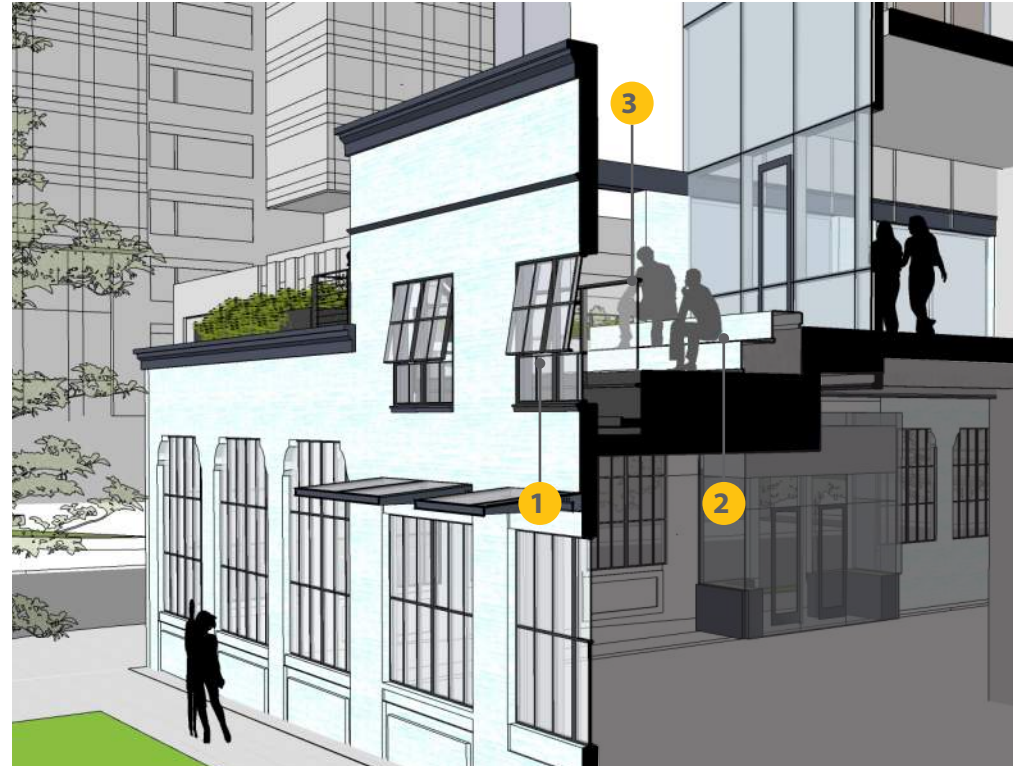
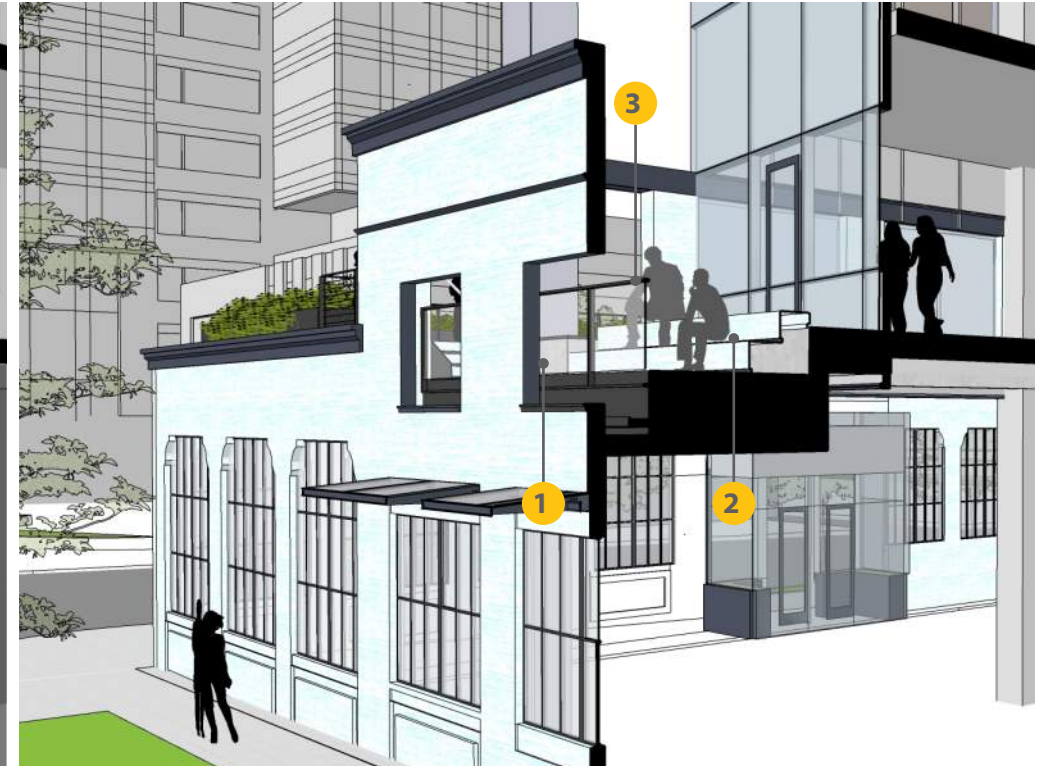
Option 1: Replacement windows, no glass

In this option, the level 2 windows are infilled with replacement windows in the style of the original steel sash windows (1). Window panes are left open (no glass) to promote visual and auditory connection to the street from seating at the terrace (2). A guardrail with infill panels is required for fall protection (3). Woven metal mesh with a high degree of transparency is proposed as the guardrail infill material.

Option 2: Replacement windows, open position

Similar to Option 1, in this option the level 2 windows are infilled with replacement windows in the style of the original steel sash windows (1). Window glazing provides fall protection, but the awning window is proposed to be in the open position to promote visual and auditory connection to the street from seating at the terrace (2). A guardrail is required for fall protection (3), however no infill/mesh is required.

Option 3 (preferred): No window, interior guardrail

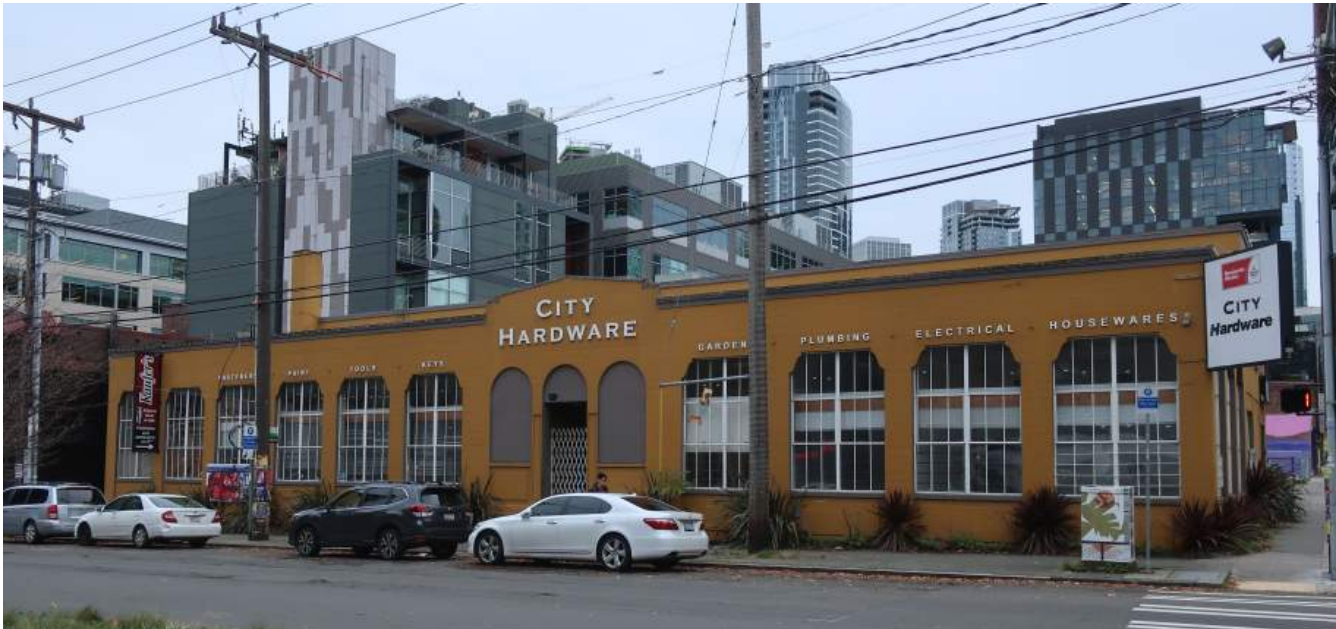
North facade, along Harrison Street

The majority of severe damage observed on the subject building is at the sills, ranging from flaking paint, cracked or missing putty, to steel delamination, full-depth corrosion, and severe warpage. Restoration would require a fairly invasive campaign to remove existing interior finishes to expose the attachments, selectively cutting out and field welding replacement sections that are beyond repair, epoxy putty repair of sections exhibiting minor deterioration, straightening sections that are sound but warped, removing existing putty and coatings to bare steel, treatment with rust inhibitor, and recoating with a robust corrosion-resistant primer, reglazing (ideally using remaining salvaged wavy glass where appropriate), and repainting. Improvements may include additional measures for moisture control via flashings or weeps, restoration of operability of the awning vents, and weatherstripping to reduce air infiltration.

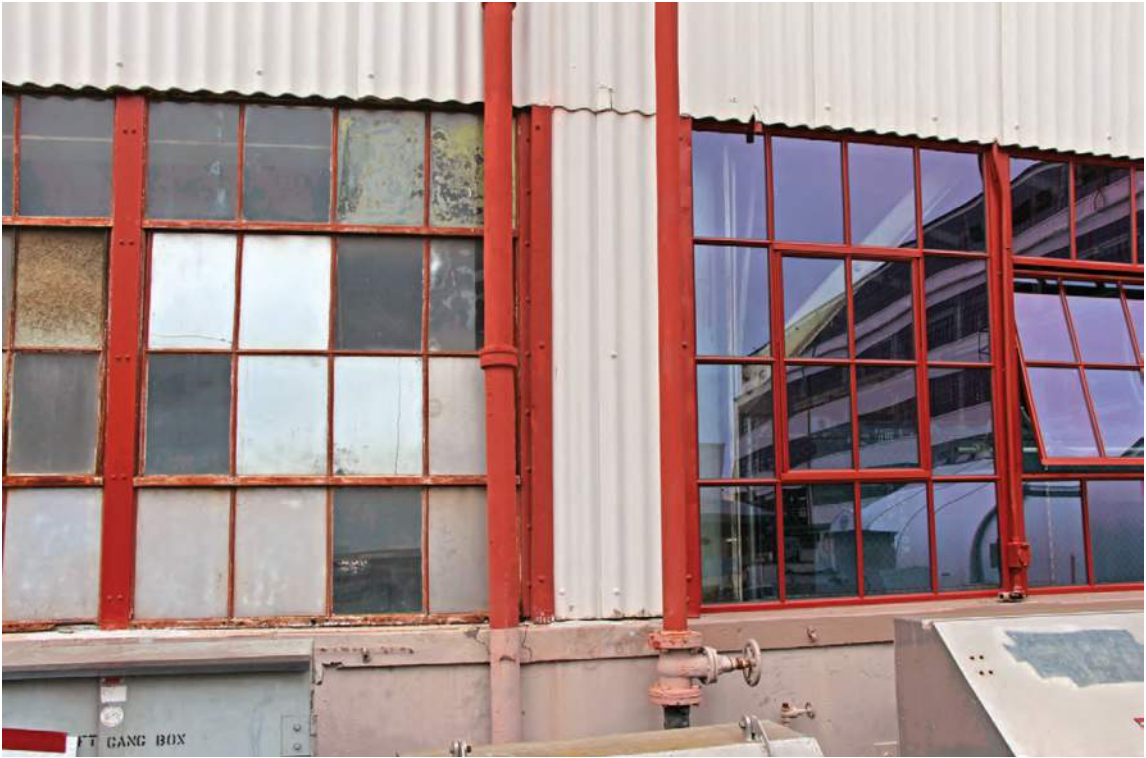
For a BEFORE and AFTER view of the windows for the Building 155 project at Pearl Harbor, please refer to photo below.

BEFORE and AFTER view of the Hope's Pearl Harbor Building 155 historic preservation project

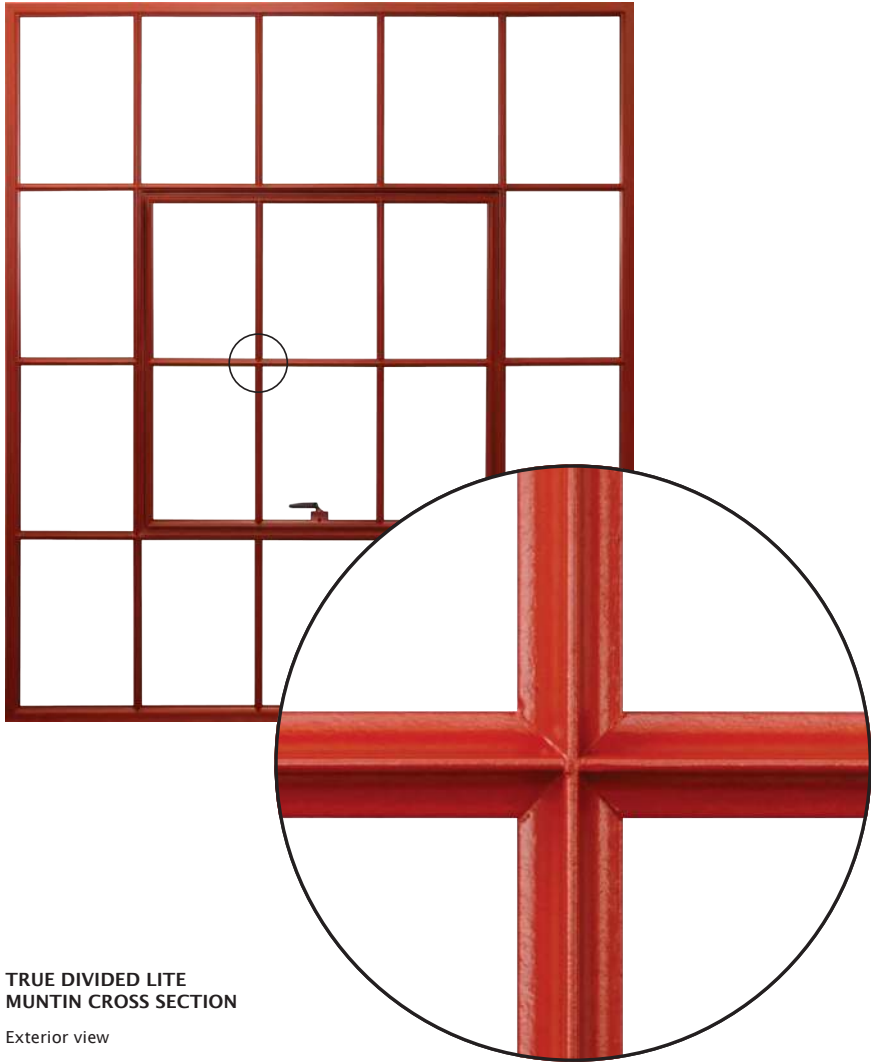
Hope's One55™ Series
Fixed, Projected, Casement and Horizontally Pivoted Steel Windows

TRUE DIVIDED LITE
MUNTIN CROSS SECTION
Exterior view

In kind replacement windows such as Hope’s Windows One55 Series or Old World Suite, with an arrow profile muntin and similar sight lines may be a suitable product.

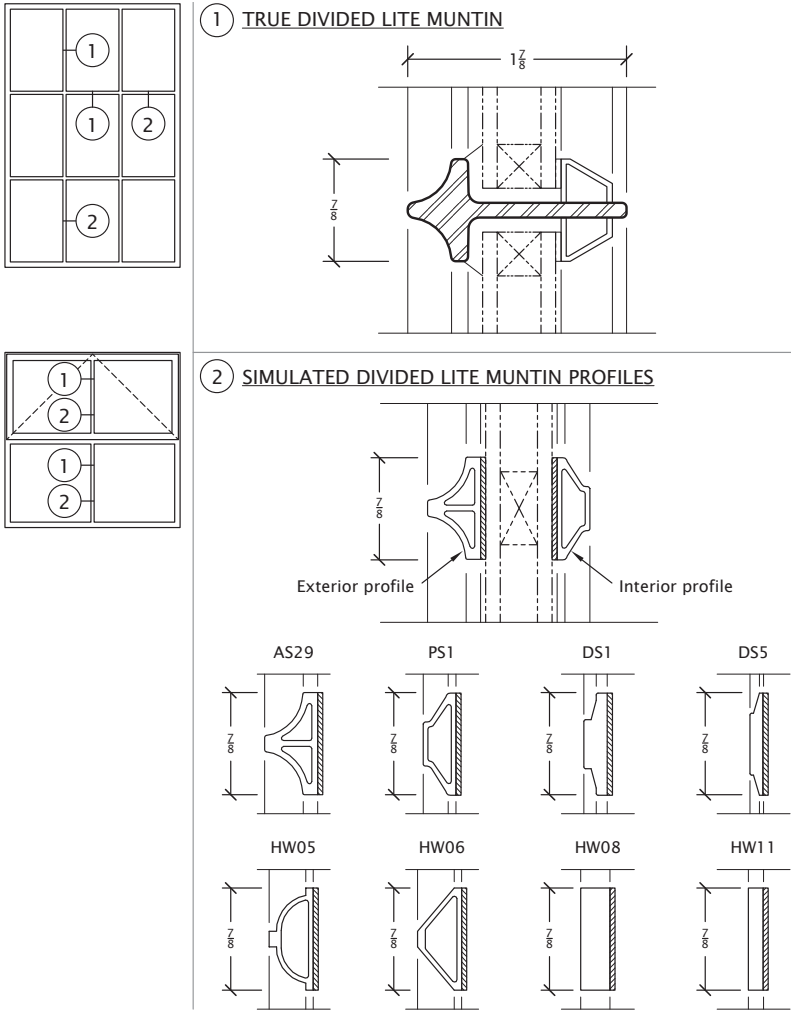
ONE55™ SERIES
Steel Window and Door
Muntin Details

Details are full scale.
All Hope's products are custom manufactured to your specific project requirements.

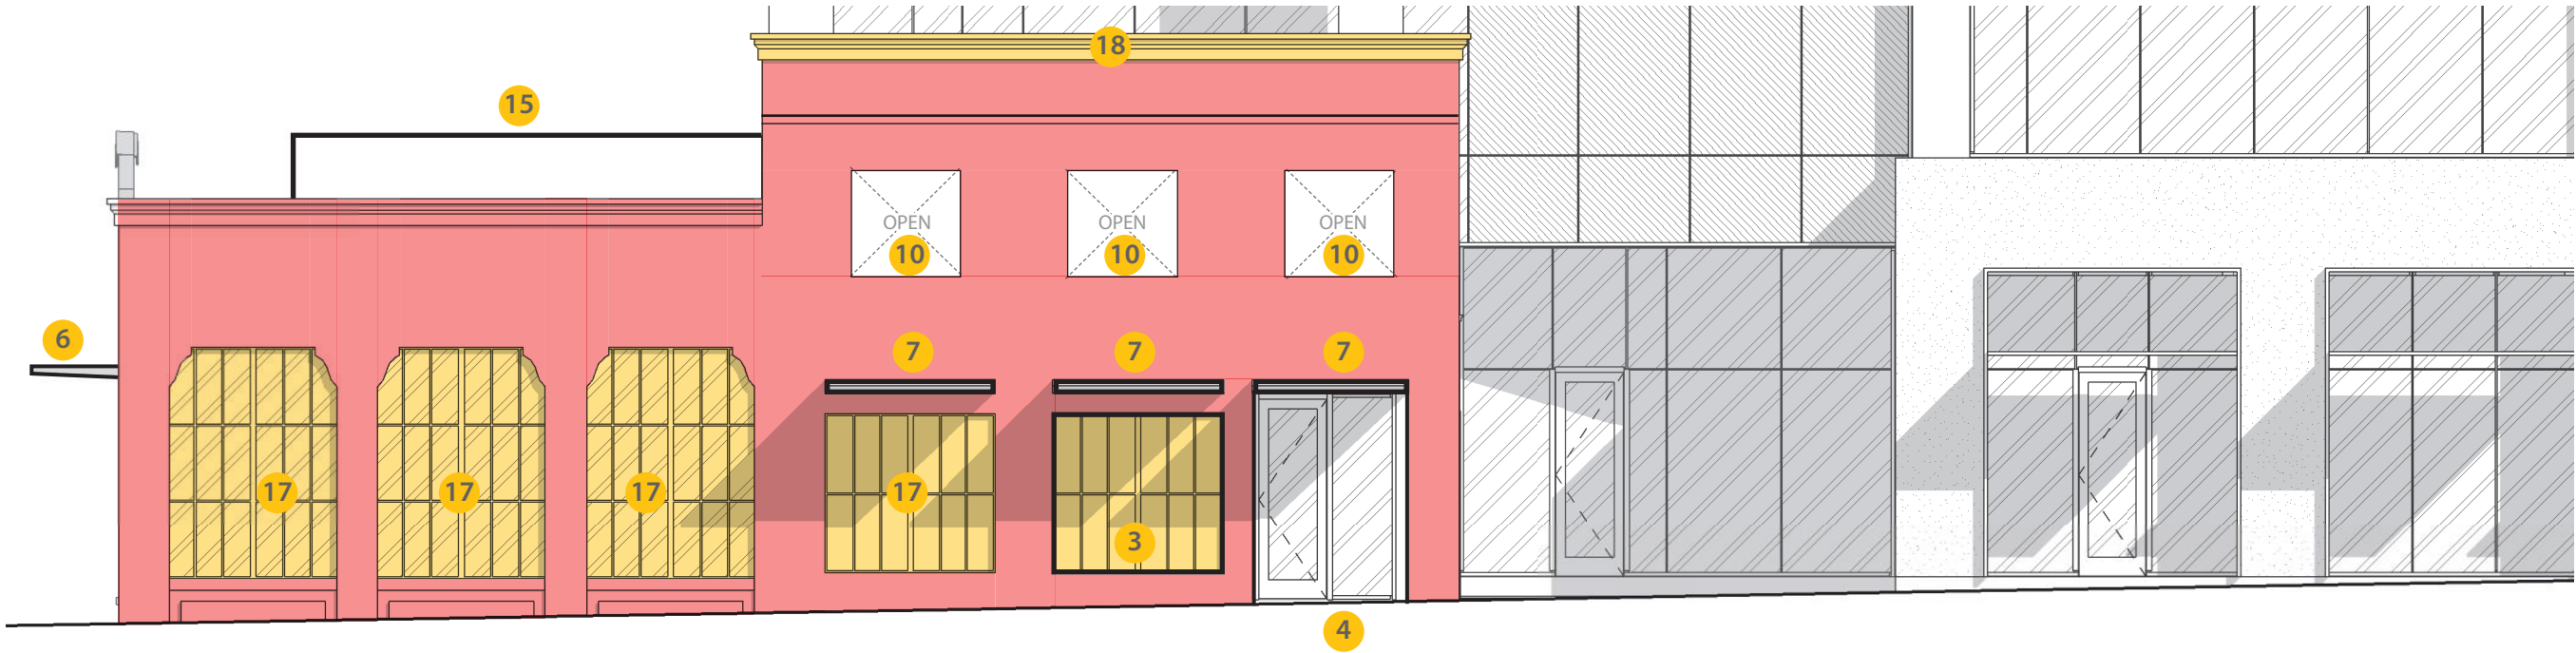
ENLARGED WEST ELEVATION
1/8" = 1'-0"

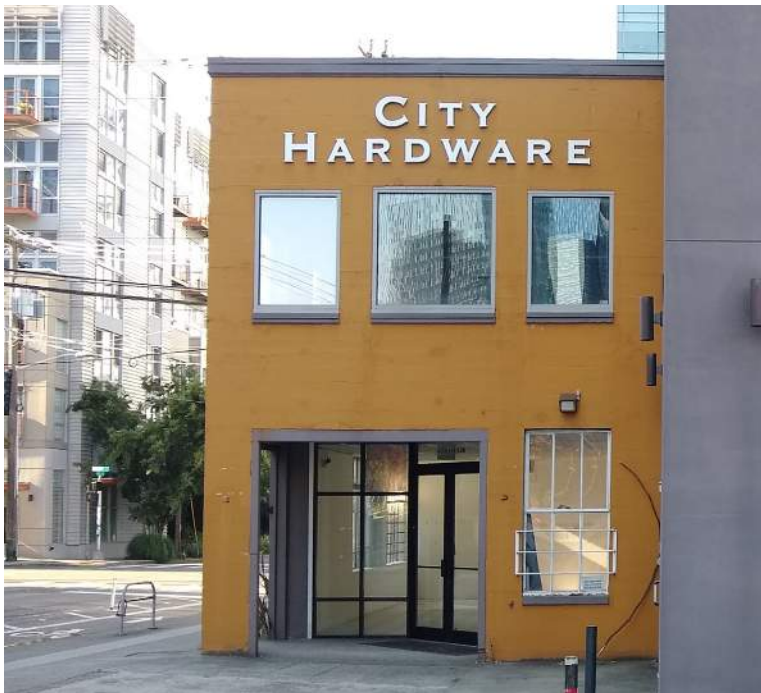
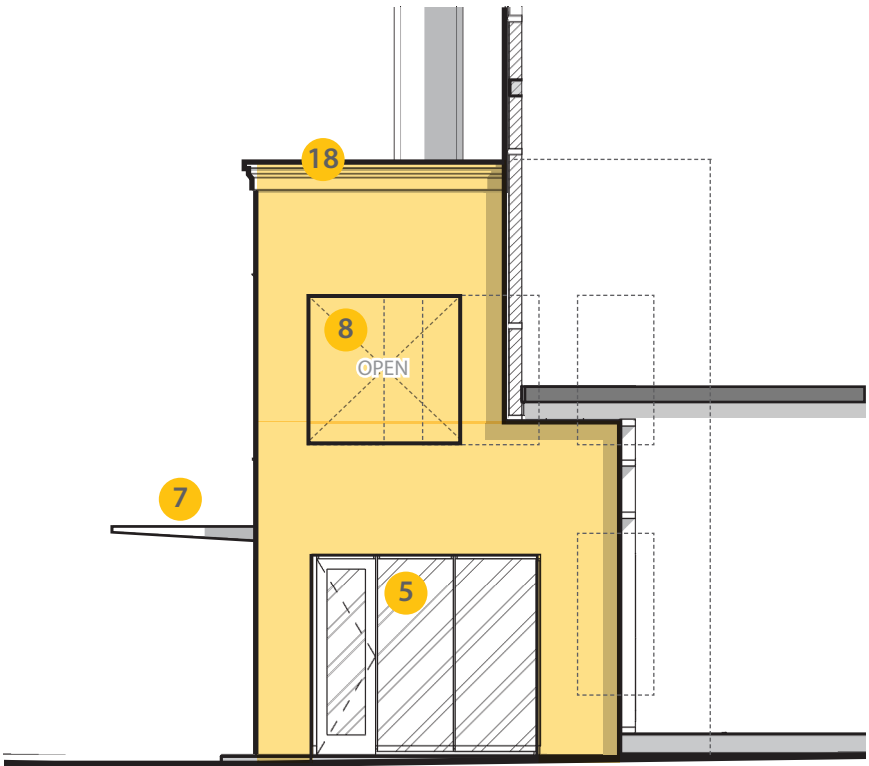
ENLARGED SOUTH SECTION ELEVATION
1/8" = 1'-0"

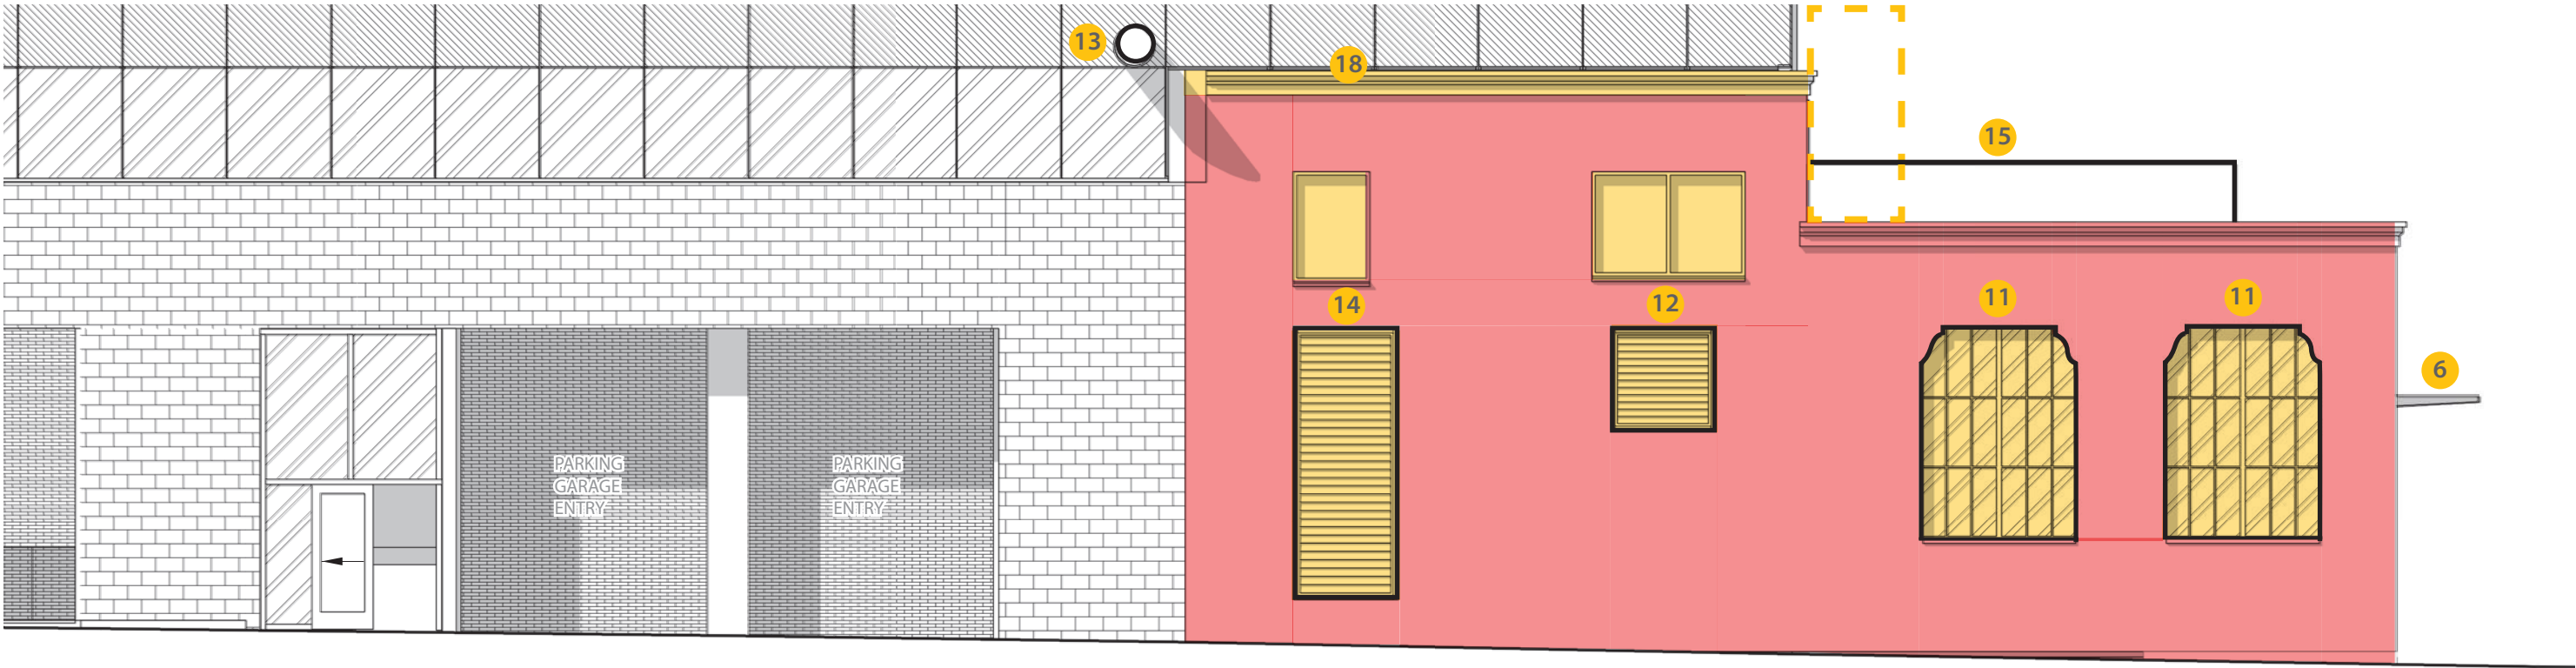
ENLARGED EAST ELEVATION
1/8" = 1'-0"

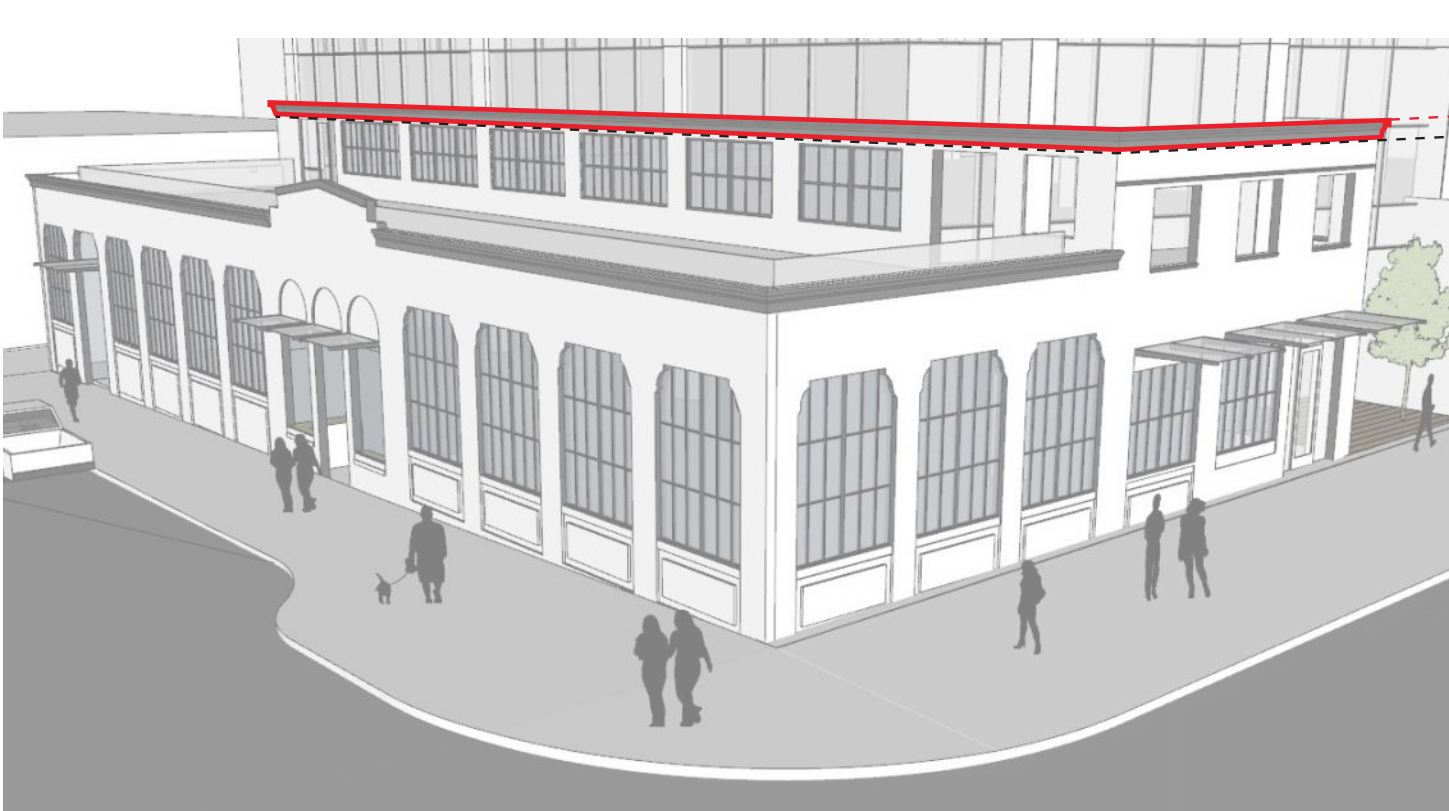
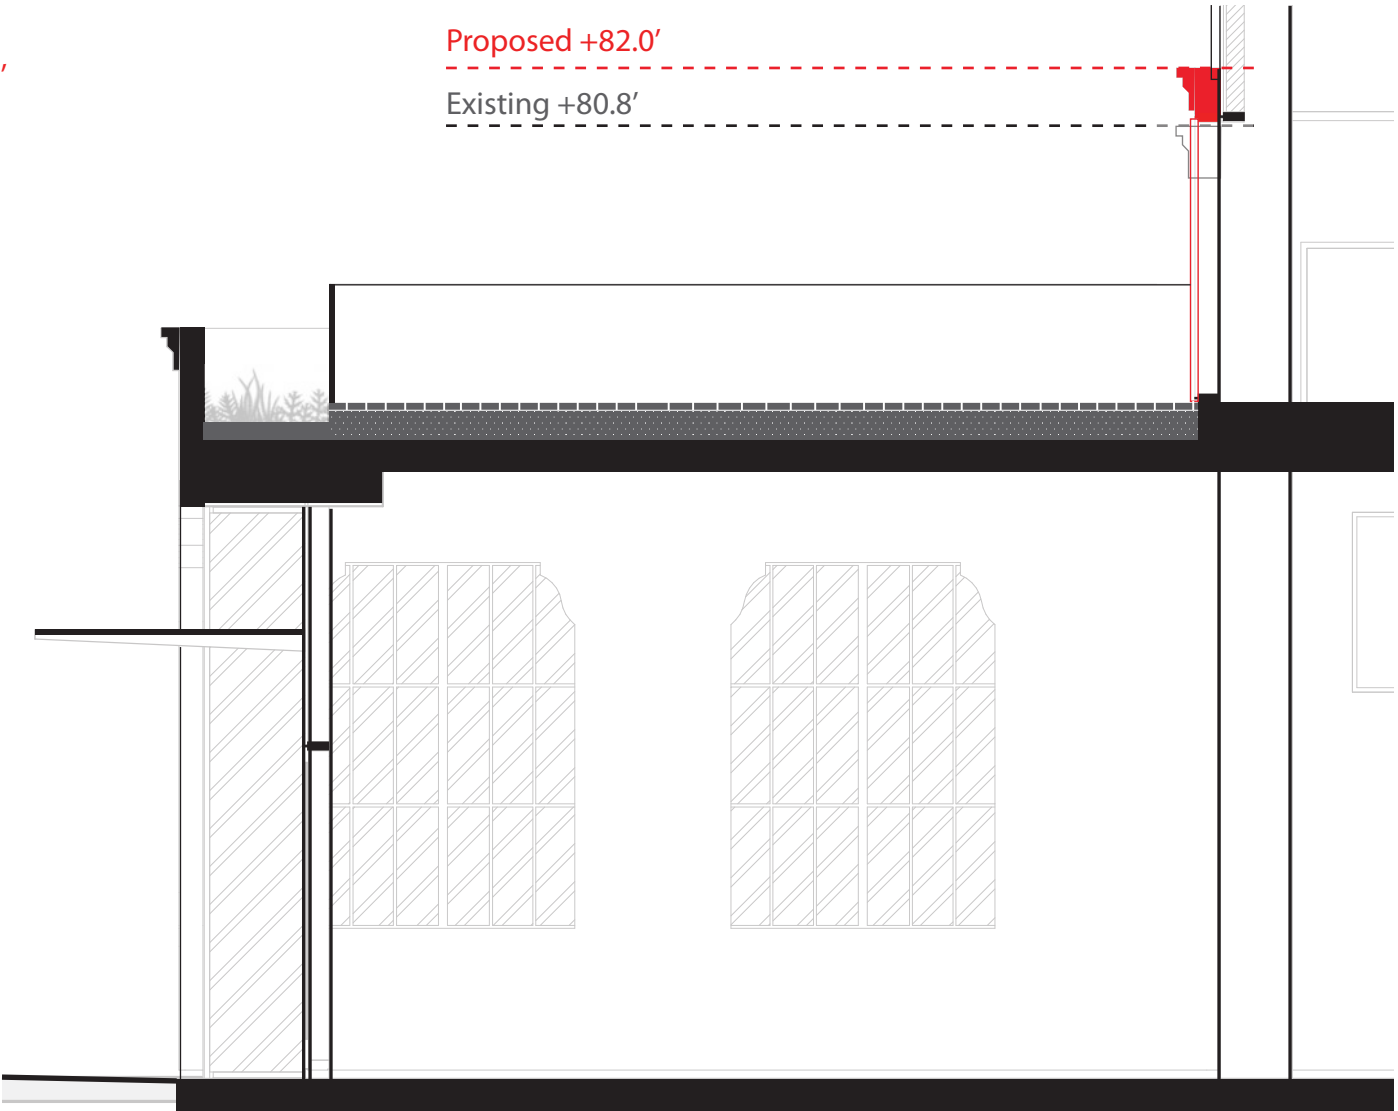
Raised Mezzanine Height

The building's current mezzanine height is at a low dimension to accommodate a new window at Level 2 to provide appropriate ceiling heights and daylighting opportunities. Since the mezzanine's north facade is being removed and rebuilt with modifications to the window sizes to maximize the daylighting opportunities and provide more window design organization, the opportunity to raise the mezzanine trim by less than 2' will provide an adequate solution for the new project while preserving the character of the landmark structure.

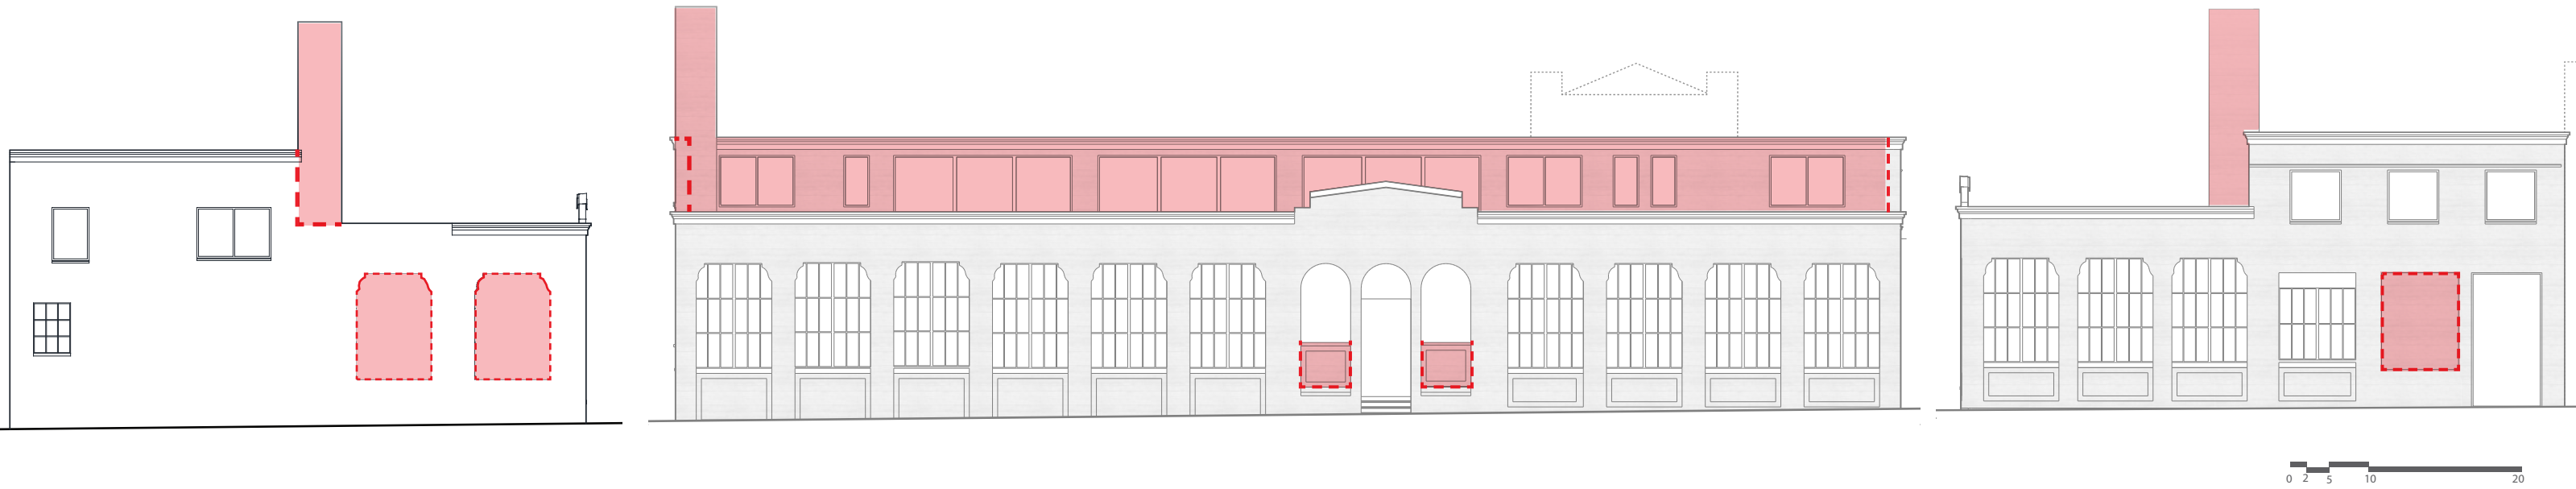
- - - Proposed Saw Cut Edges
- Proposed Facade Removals

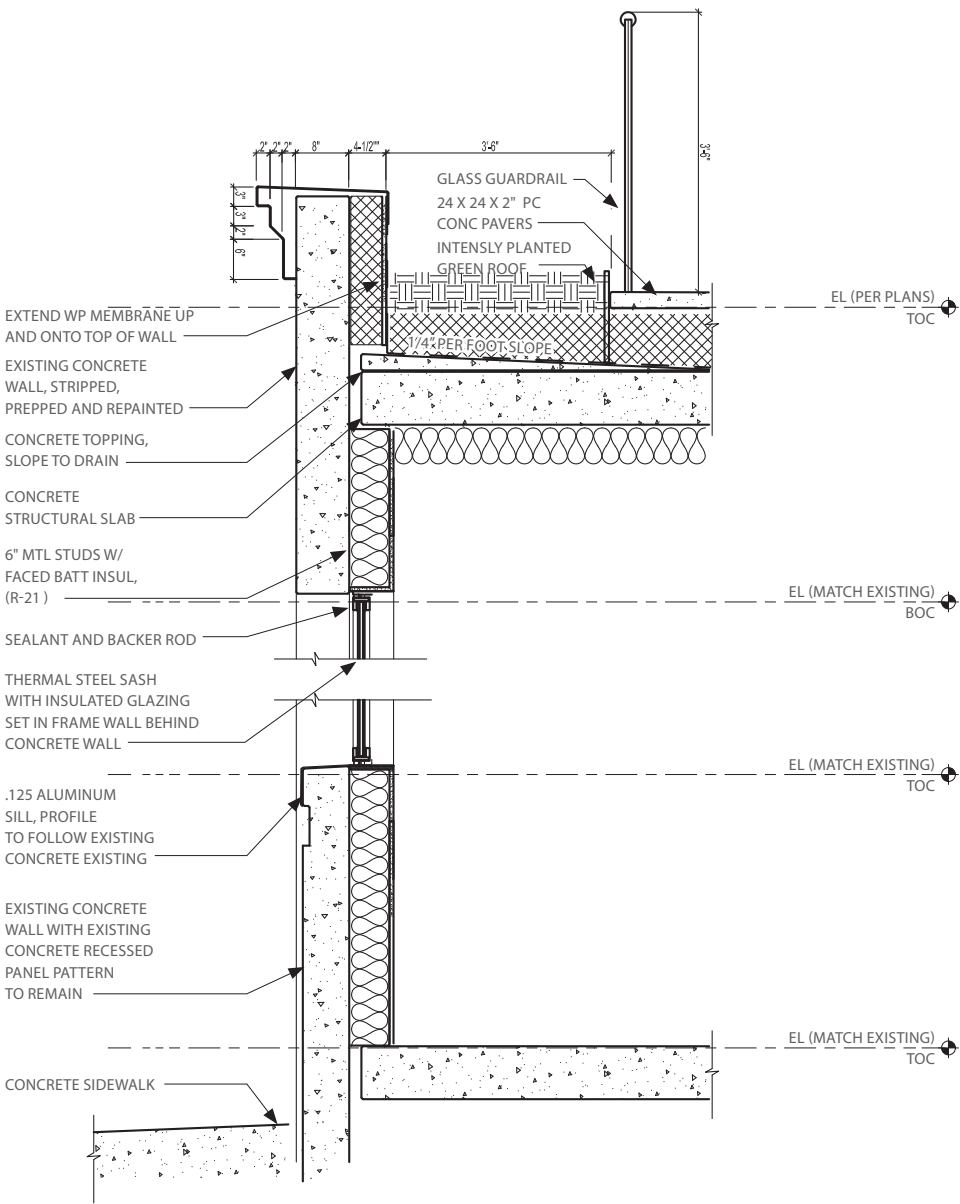
1 LANDMARK BUILDING WALL SECTION AT GRADE
3/8" = 1'-0"

The following conditions cover the extents of landmark modifications in detail format. These include the added retail entry on Harrison Street, the main retail entry on Harrison Street, the new window replacements and interior wall condition and the new mezzanine detail connecting to the new tower. The details are on the following page.

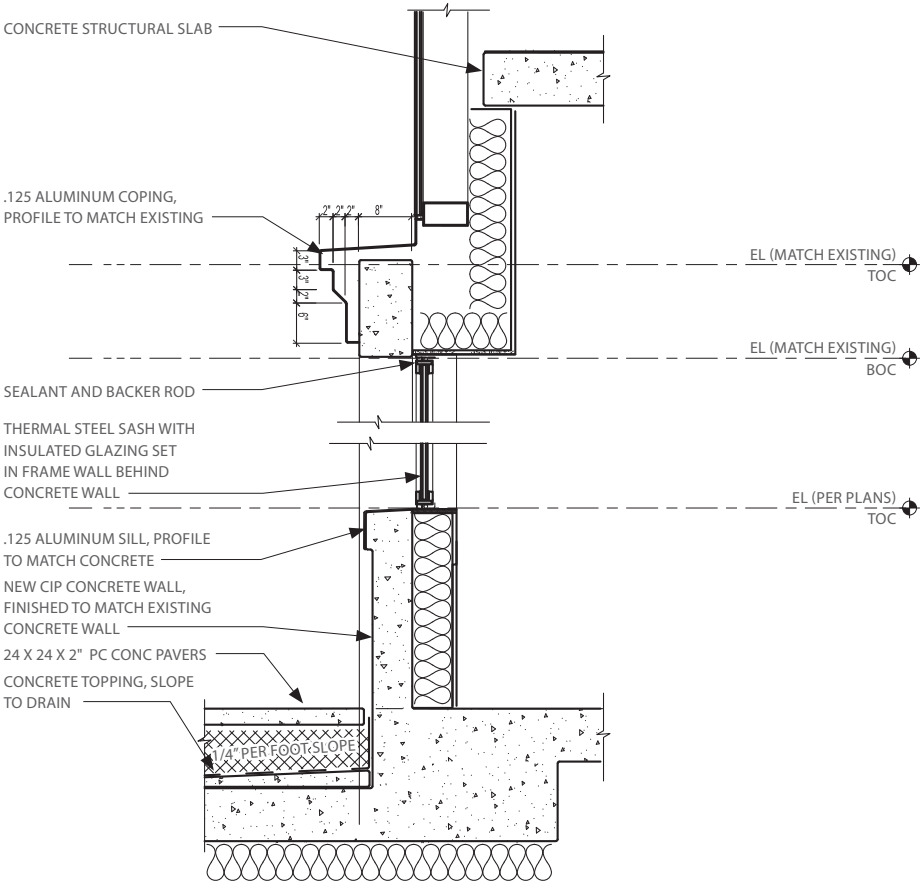
2 LANDMARK BUILDING WALL SECTION AT TERRACE
3/8" = 1'-0"

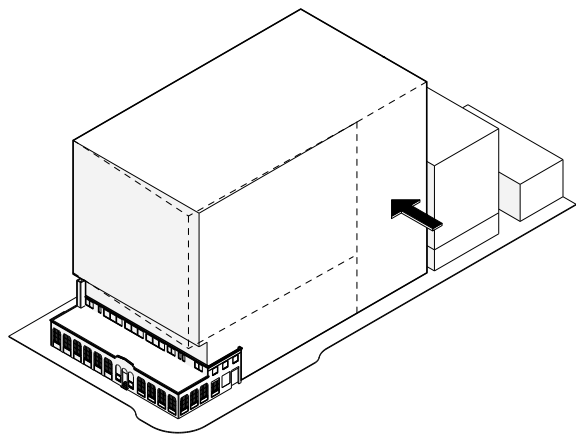
1. Modulate

Utilize the building modulation requirements to emphasize the entrance at grade.

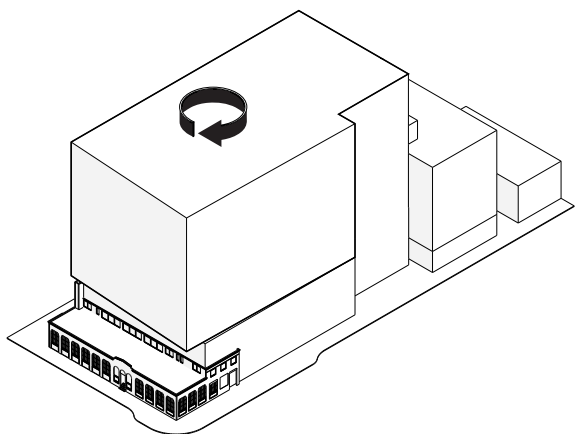
2. Twist

Breaking the rigid form of the city grid, twist the tower to engage diagonal view corridors

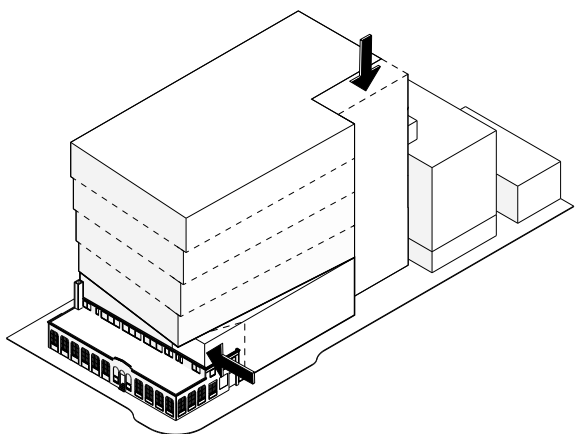
3. Carve

Carve out space between prominent building features and express voids as articulation

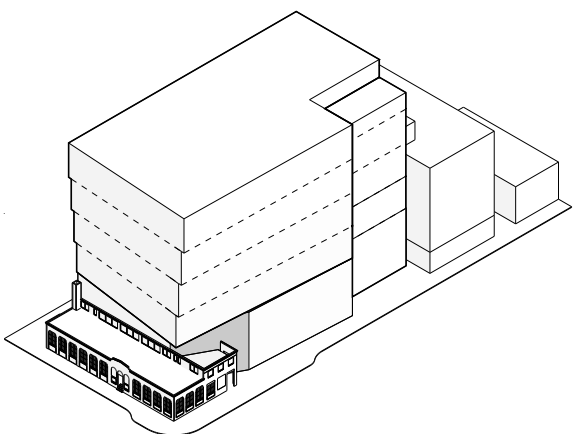
4. Sculpt

The result is a sculpted tower that rises and breaks from the modular form of the ground level & city grid.

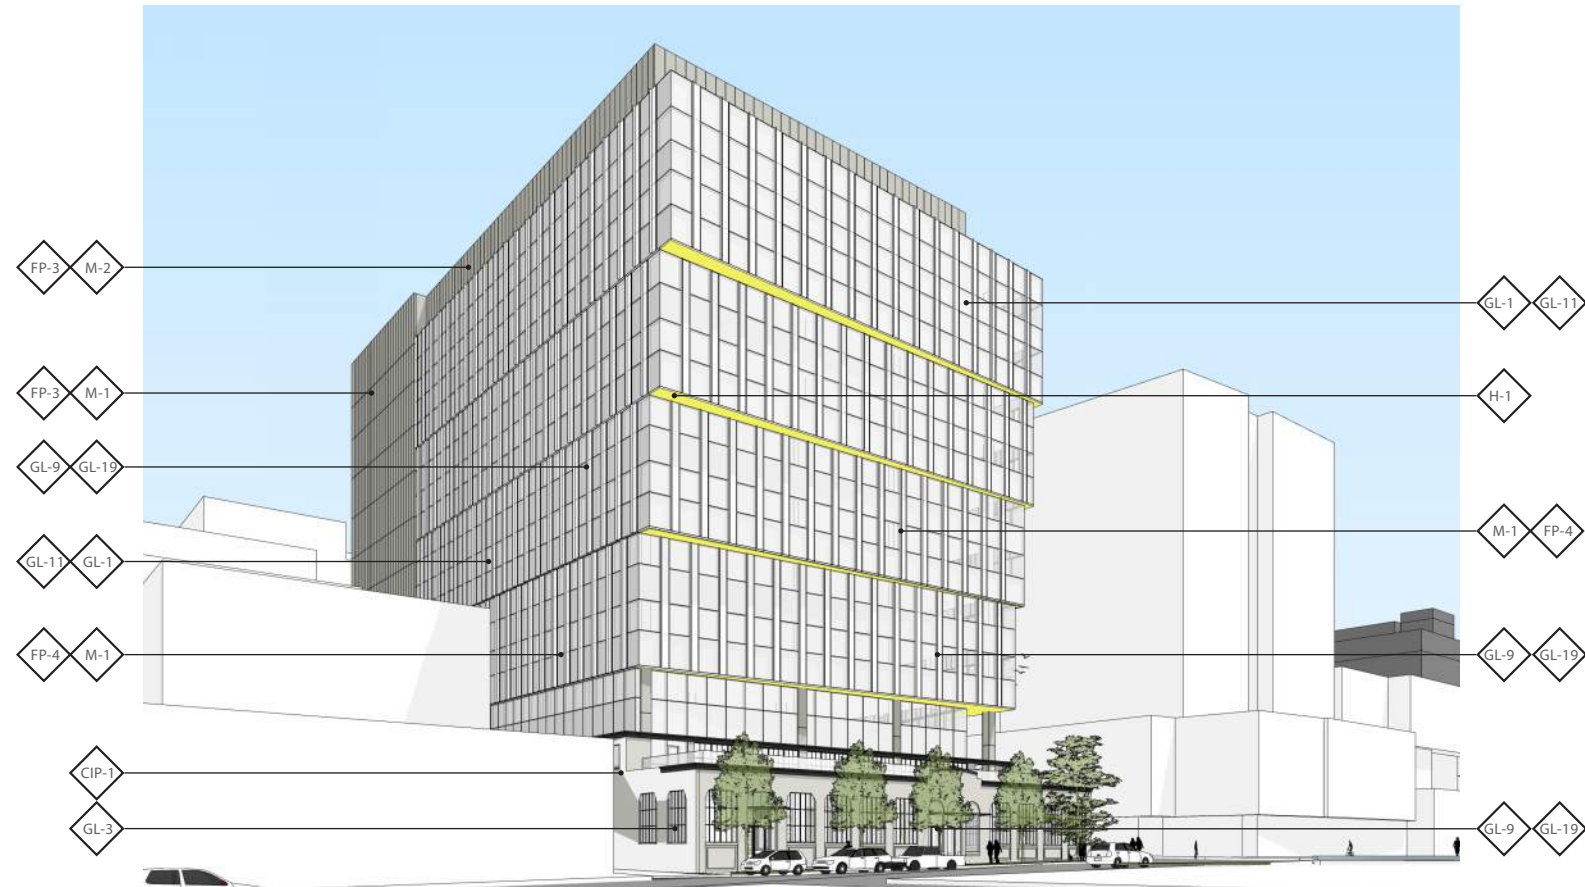
Harrison Street view looking Southwest
